Big Creek Watershed Improvement Plan

Prepared for
Forsyth County Engineering Department

Prepared by
CH2MHILL

October 2007

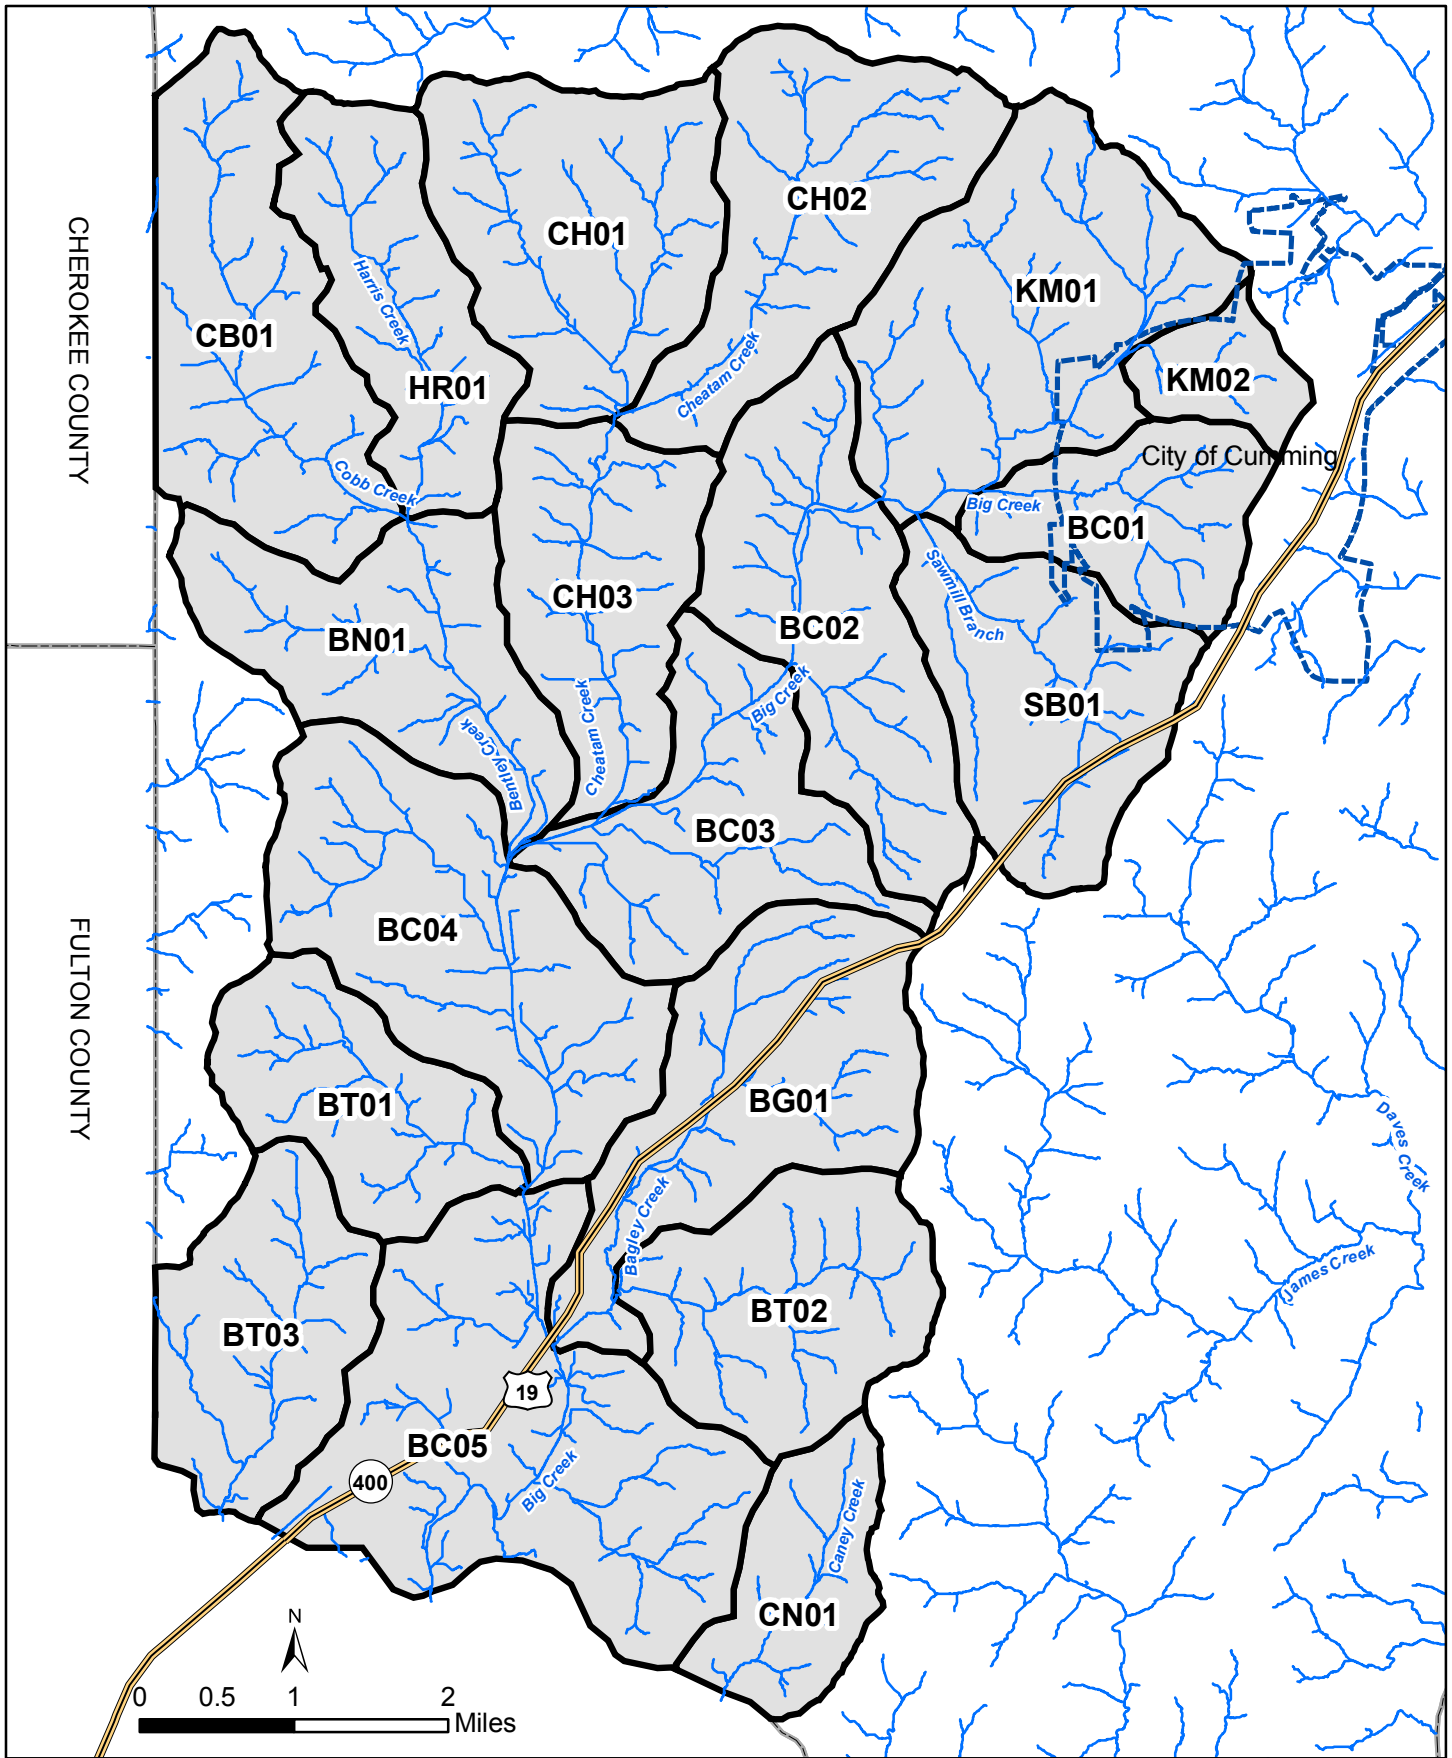
Figure 2
 Subwatersheds
 Big Creek Watershed Improvement Plan
 Forsyth County, GA

As described in Section 2.0, the Big Creek Watershed was divided into 19 subwatersheds with drainage areas ranging from 0.73 to 5.38 square miles (Figure 2). Subwatersheds were delineated to provide a more manageable size for selecting, organizing, presenting, prioritizing, and implementing projects recommended in this WIP. Priority subwatersheds were also identified where the effective impervious cover was greater than 10 percent.

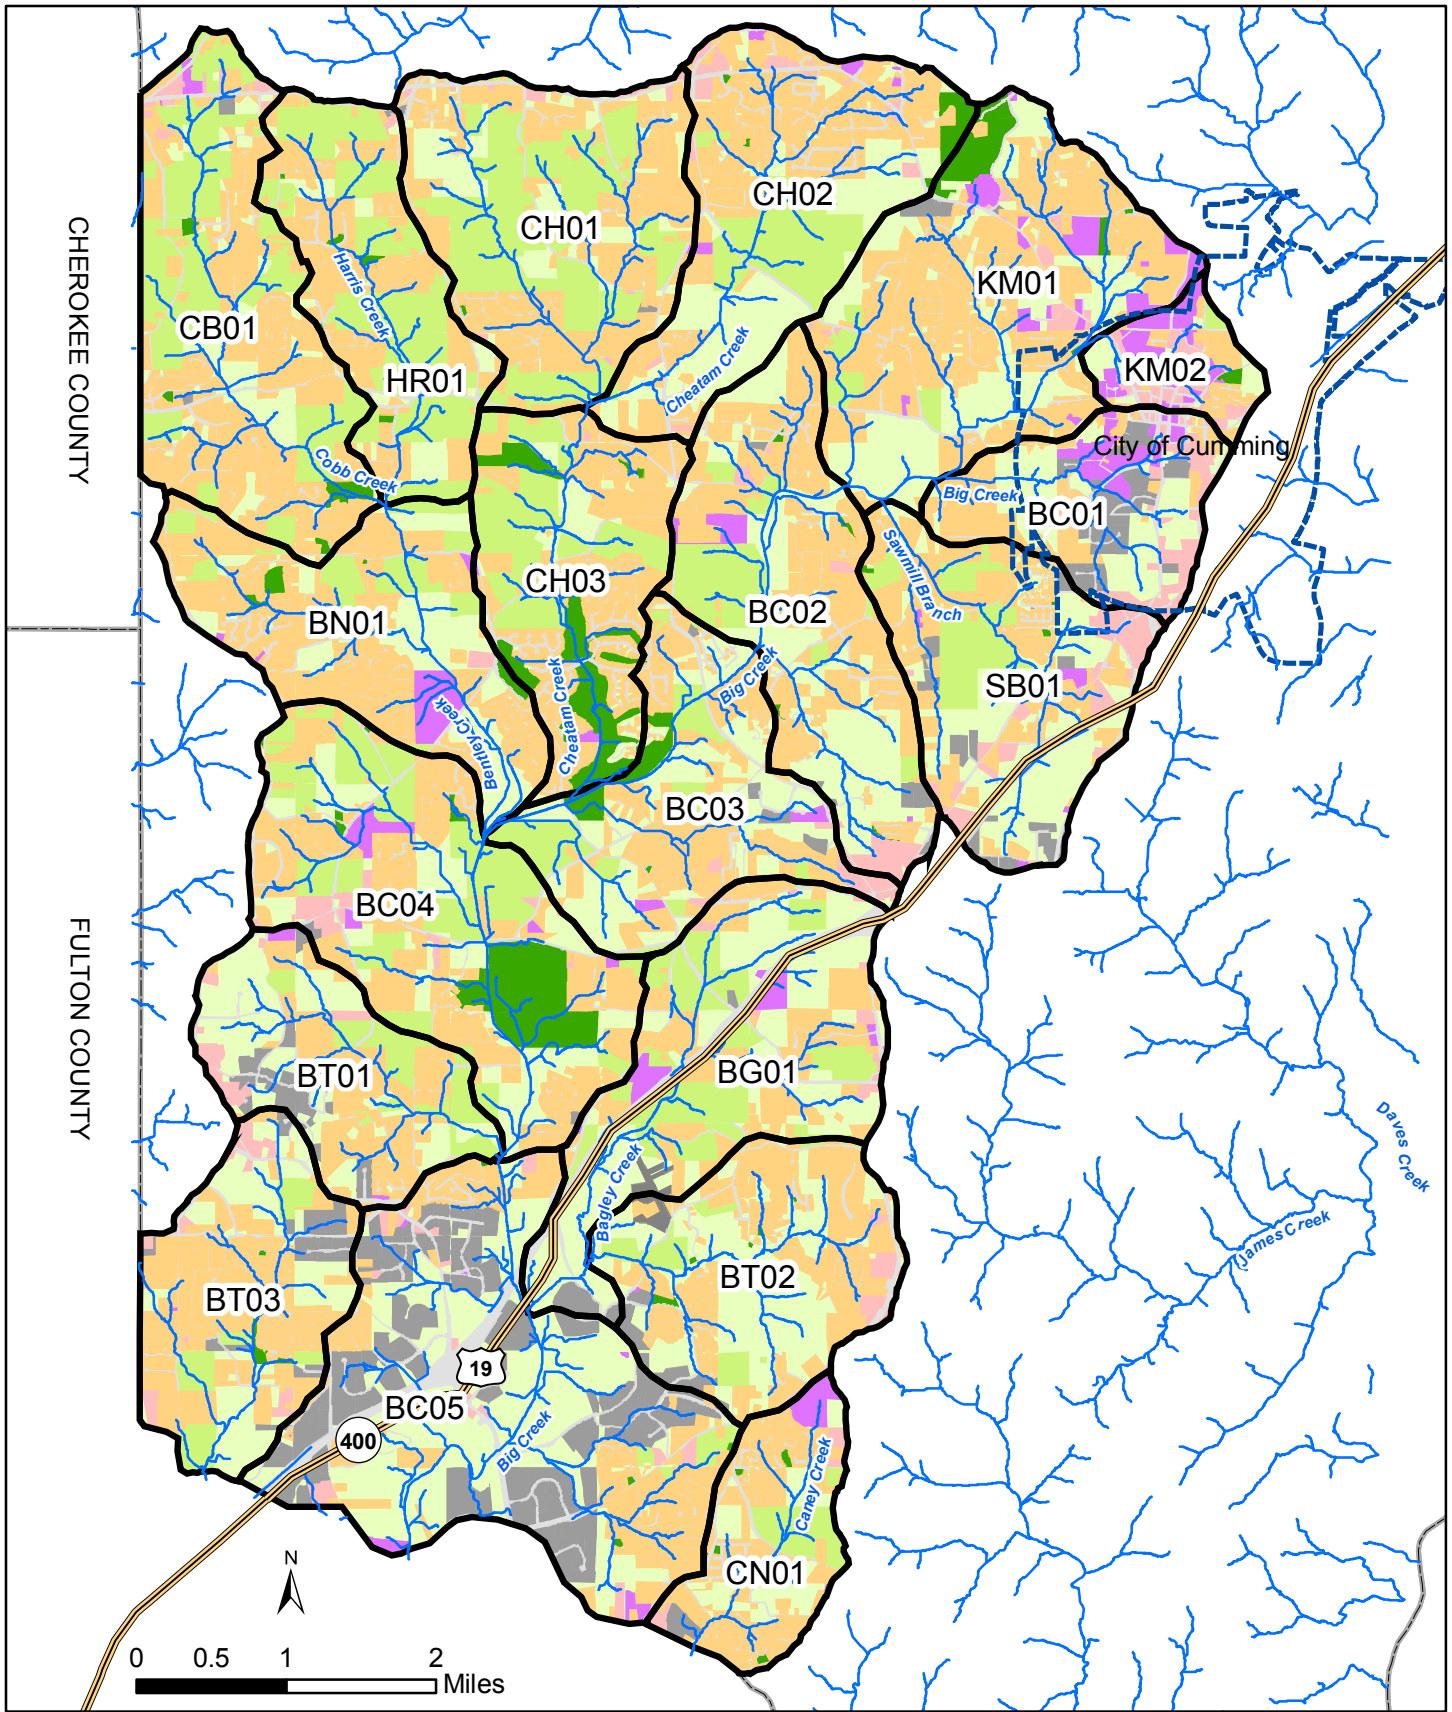
Figure 3
 Land Use by Subwatershed
 Big Creek Watershed Improvement Plan
 Forsyth County, GA

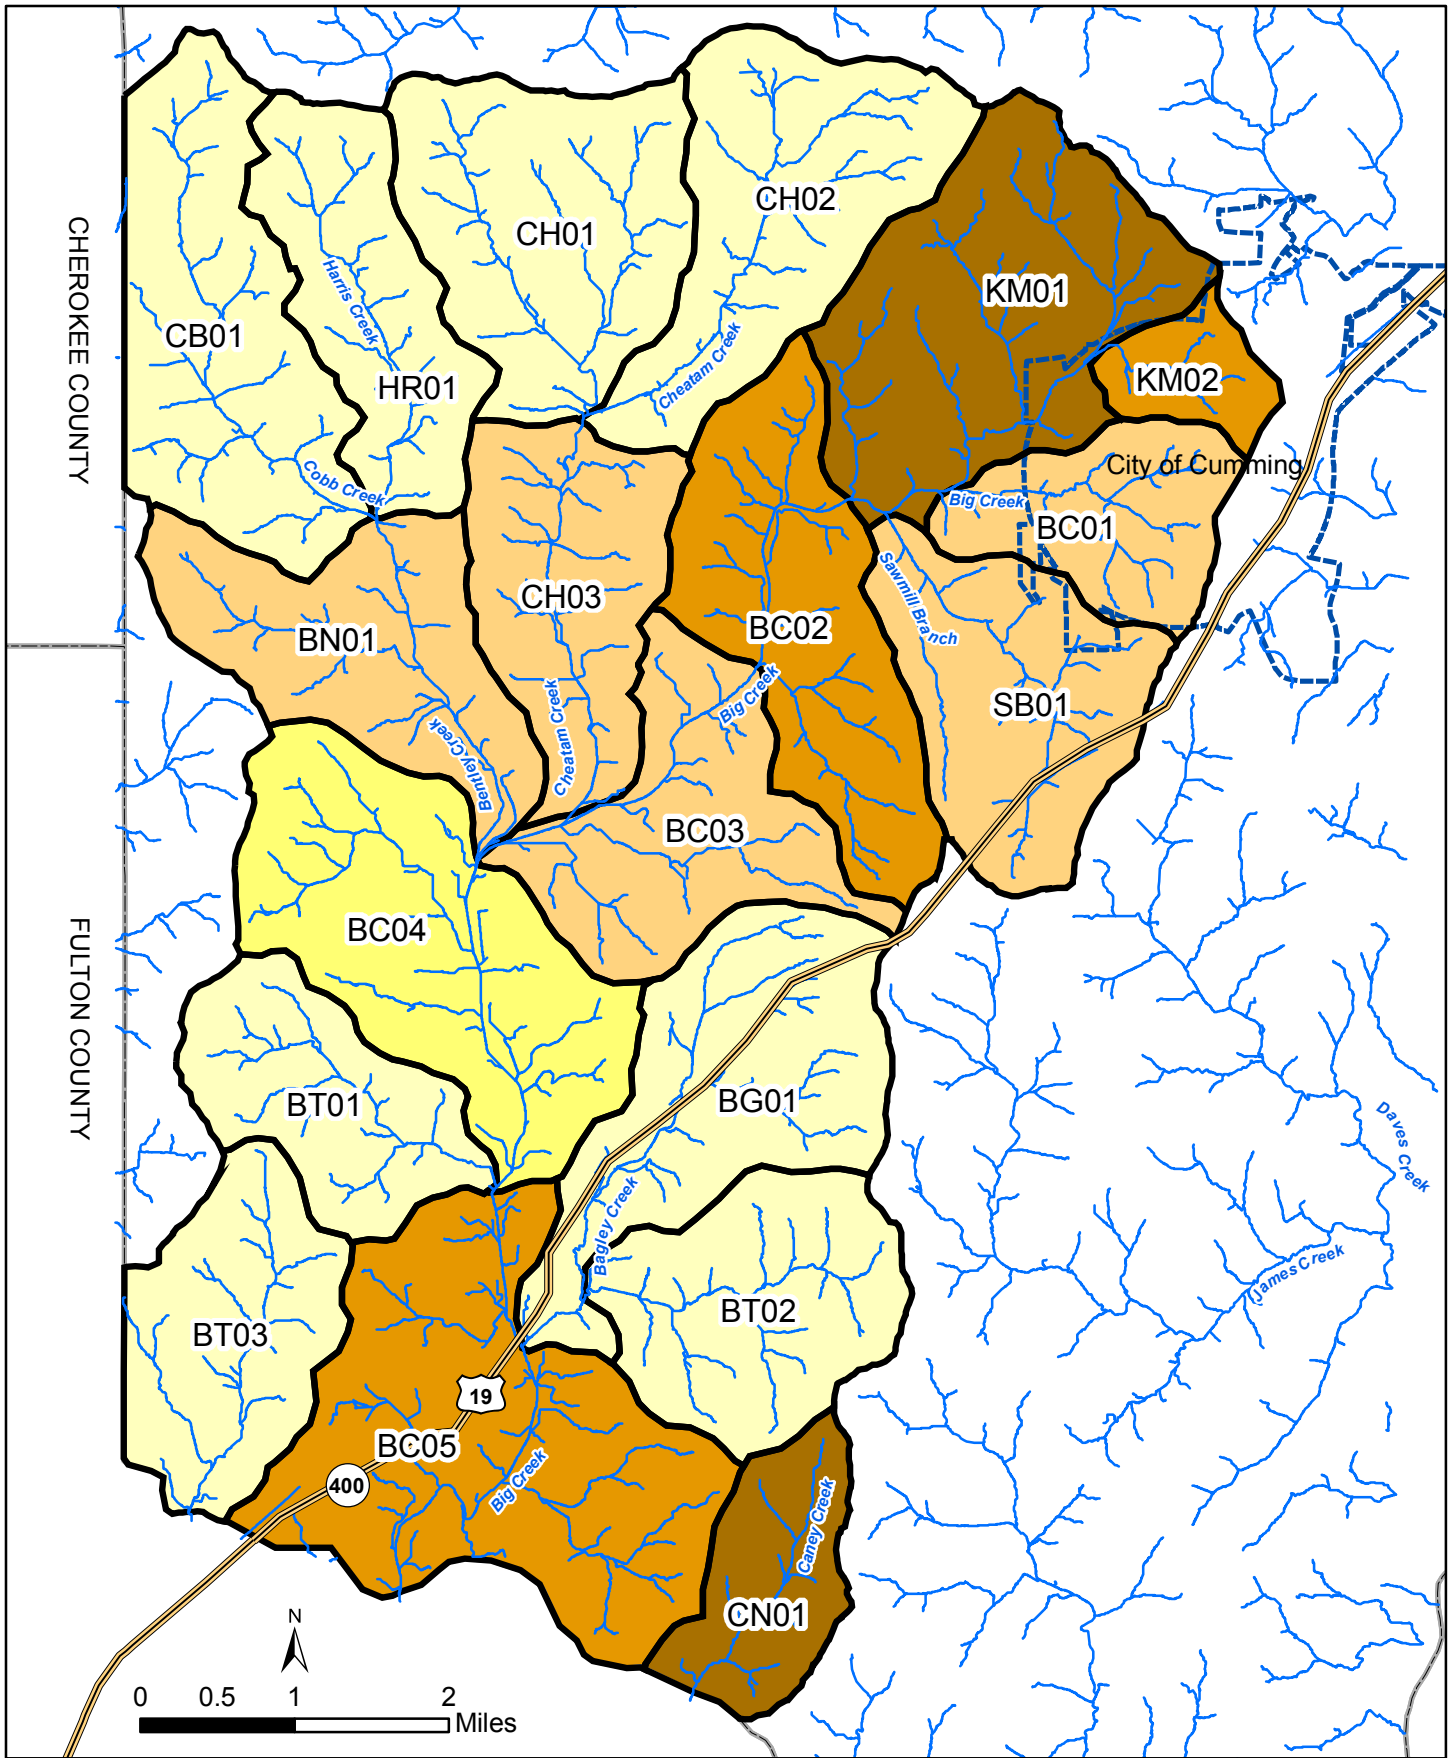
Figure 4
 Population Density
 Big Creek Watershed Improvement Plan
 Forsyth County, GA

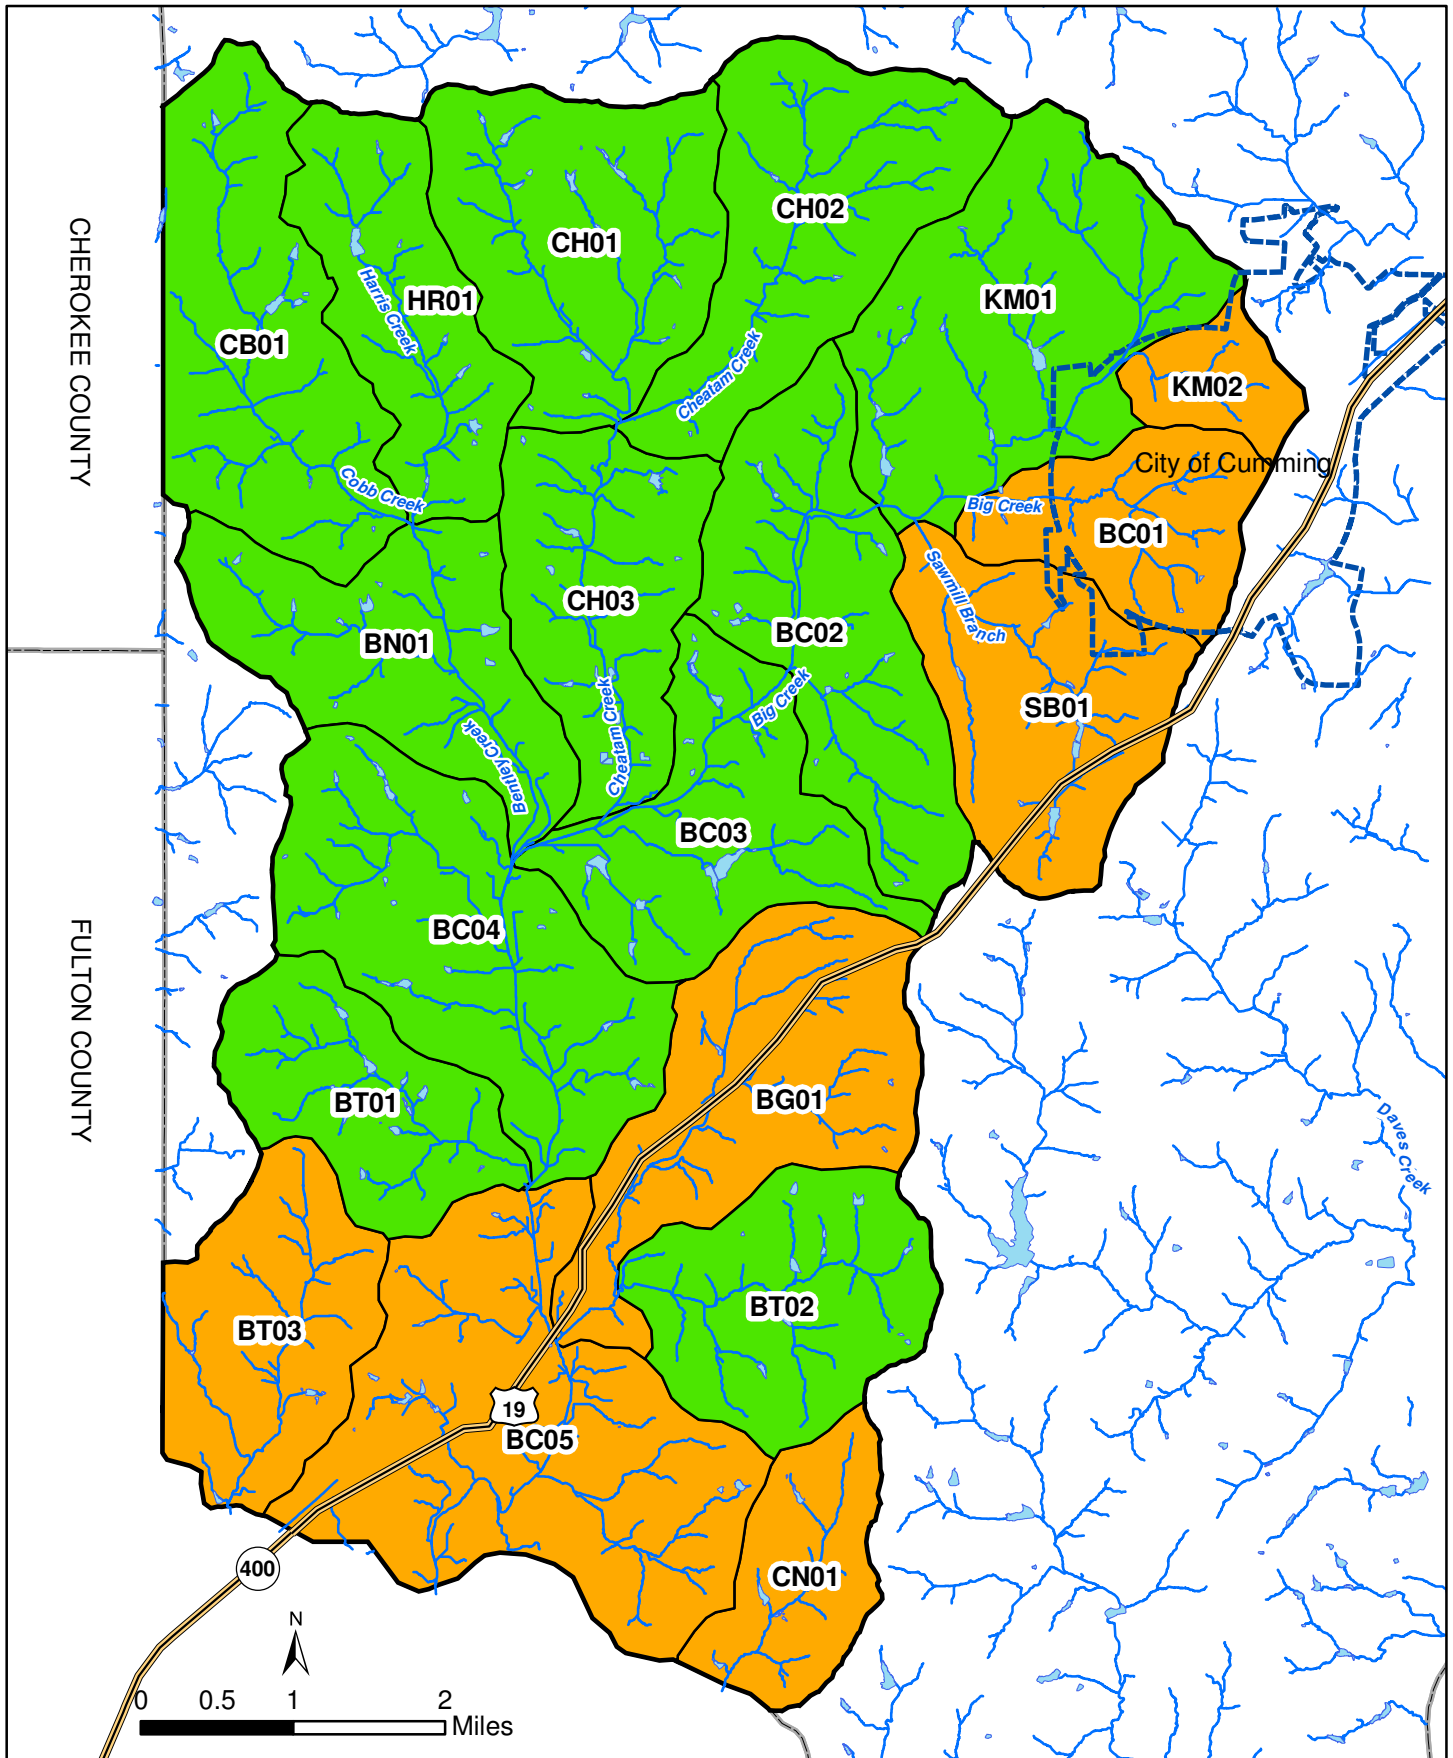
Figure 5
 Effective Impervious Cover
 Big Creek Watershed Improvement Plan
 Forsyth County, GA

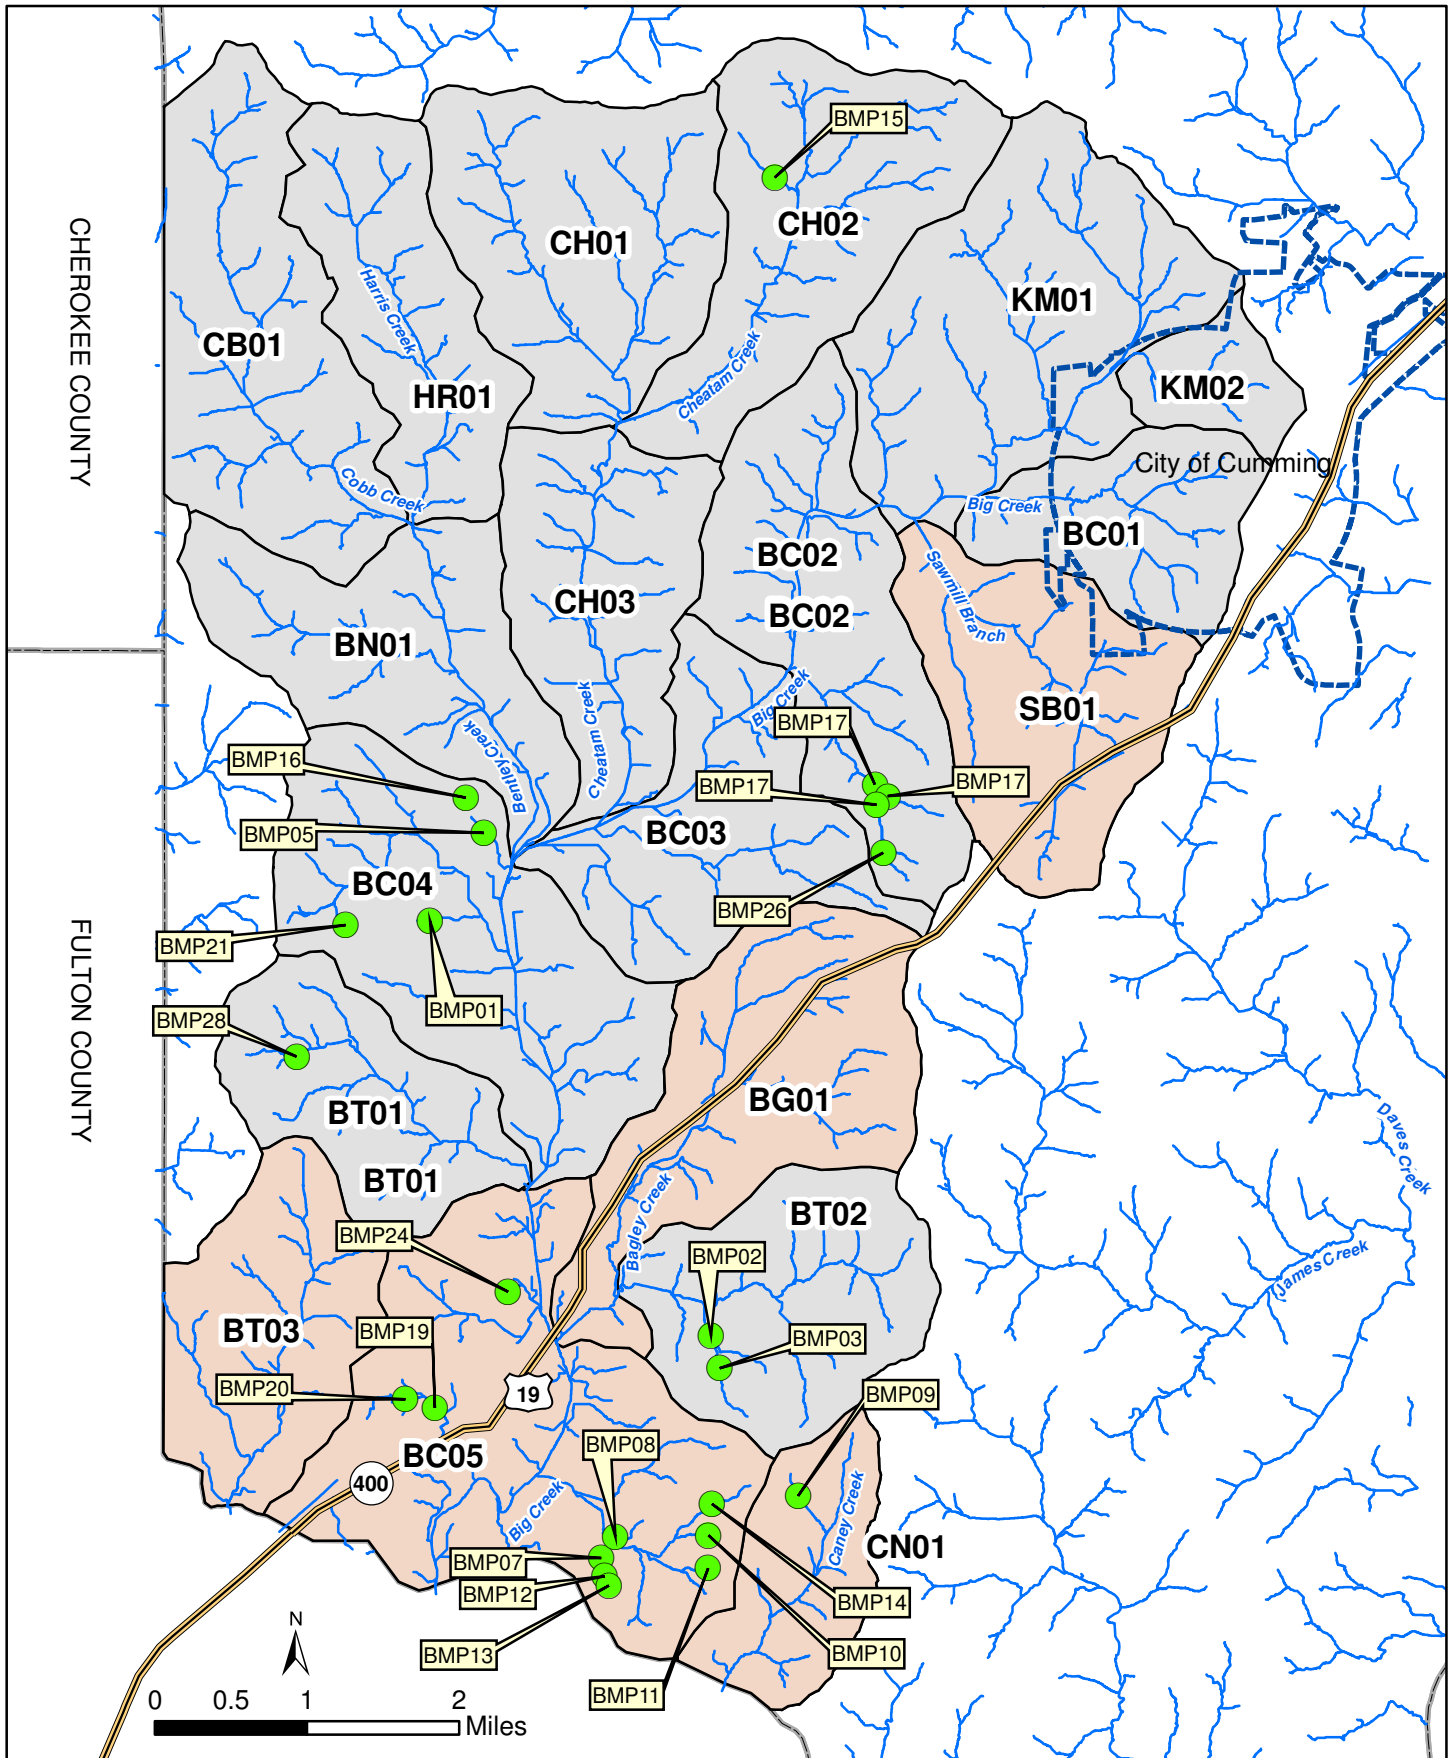
Figure 6
 BMP Retrofit Project Locations
 Big Creek Watershed Improvement Plan
 Forsyth County, GA

The field reconnaissance identified BMPs that were functioning properly, as well as BMPs with potential problems in functioning and design. Of the 39 initial potential BMP retrofit projects, 21 projects were identified as requiring retrofits and selected for evaluation in the cost and benefit analysis in Section 4.0. Just over half of the 21 projects were located in BC05 and CN01, which are the two priority subwatersheds with the highest impervious cover. In many instances, BMP structures were providing inadequate stormwater capacity and were (1) designed for use during construction and then abandoned after serving their build-out purpose (Photo 1), (2) in-stream features actively contributing to degraded channel conditions (Photo 2), or (3) improperly built or maintained to serve a useful purpose (Photo 3). Recommendations for these projects are summarized in Table 3. Recommended project techniques are discussed in the following section. Project locations are shown in Figure 6.

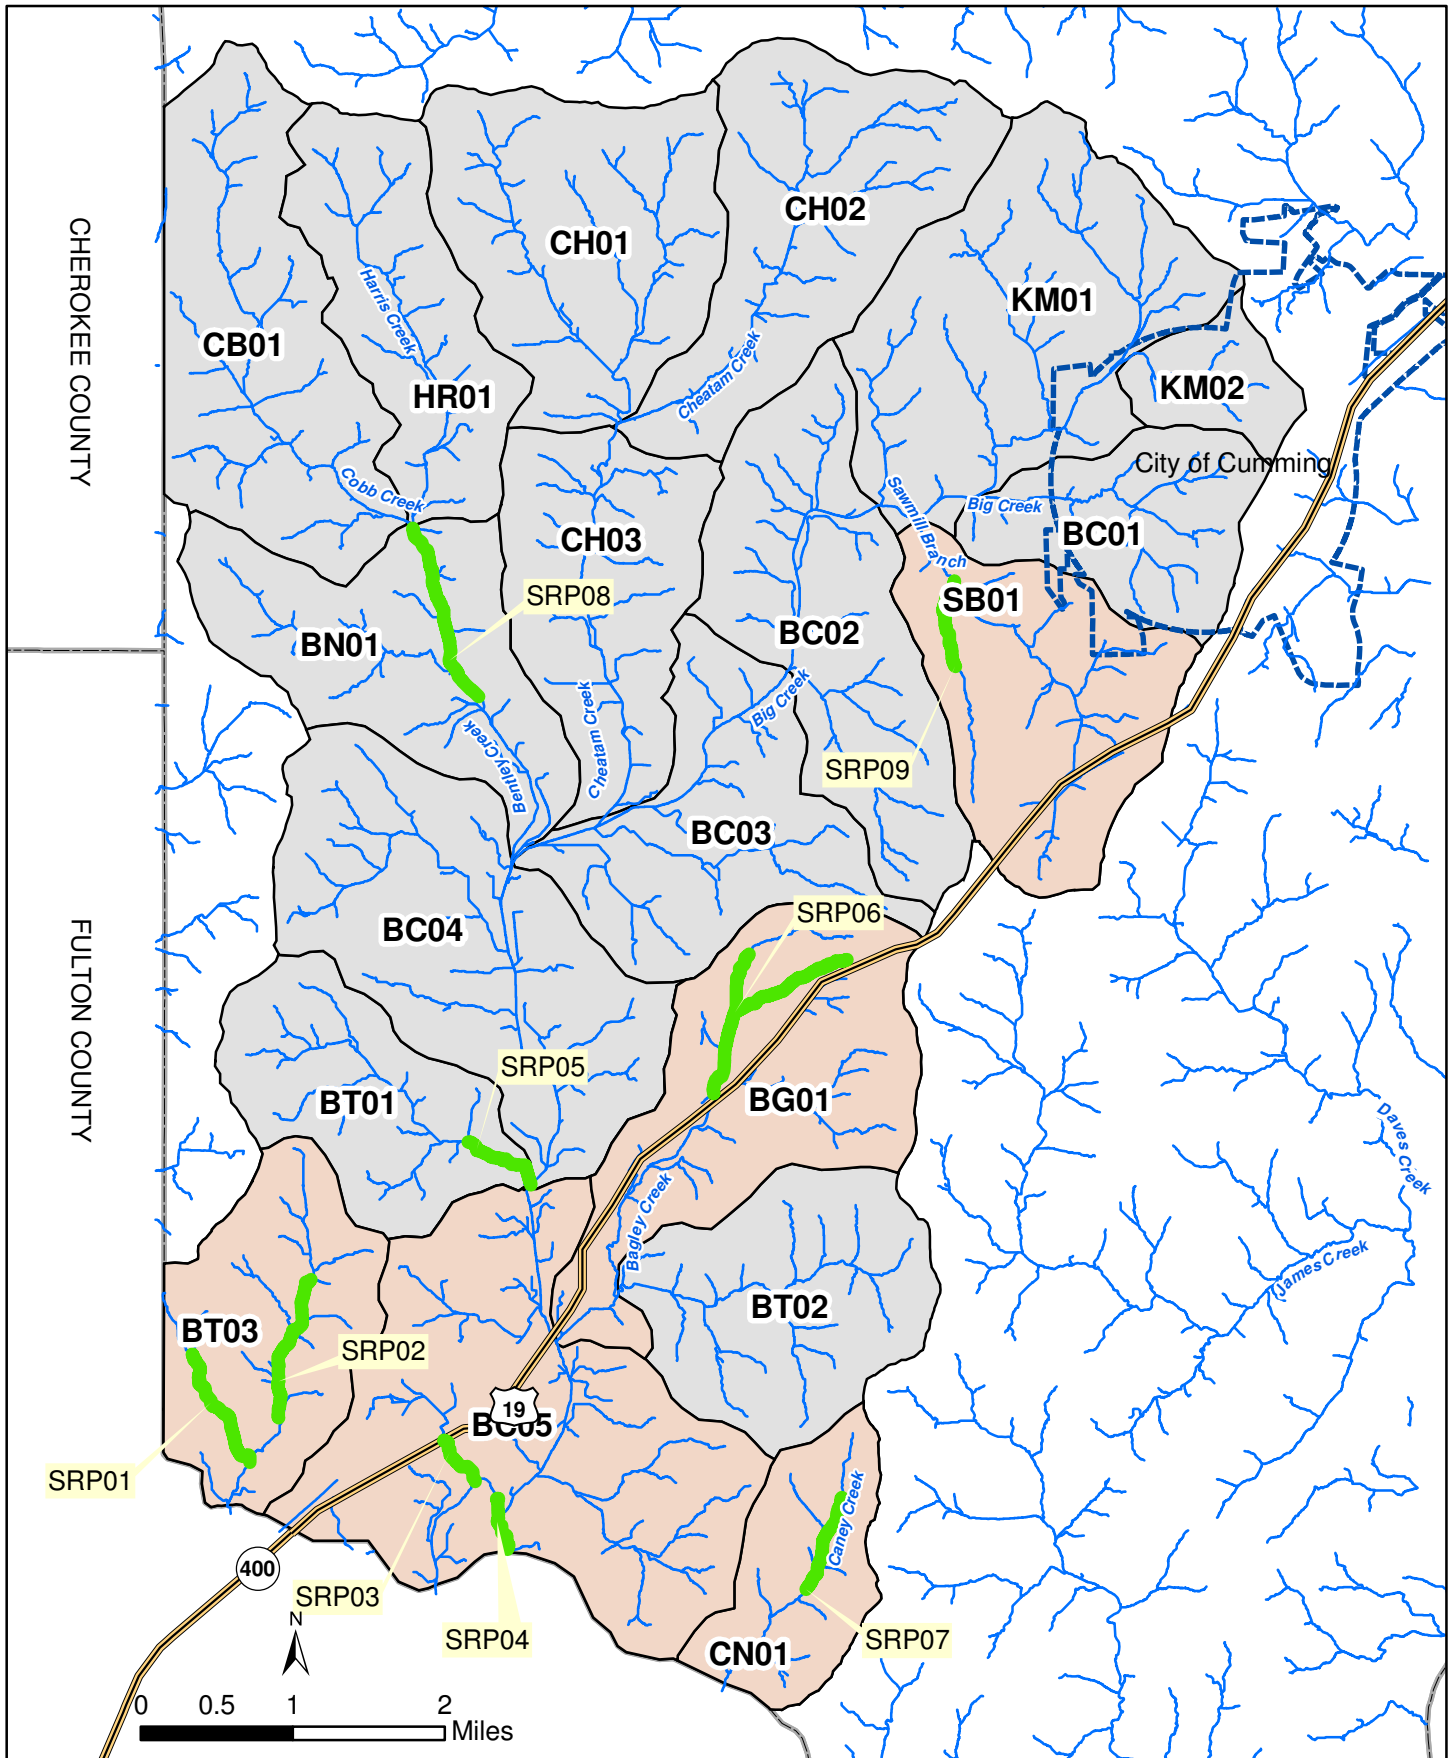
Figure 7
 Stream Restoration Locations
 Big Creek Watershed Improvement Plan
 Forsyth County, GA

The field reconnaissance identified some stream reaches that appeared to be stable, but most showed signs of degradation. Of the 10 initial potential stream restoration projects, 8 projects were identified for potential restoration and selected for evaluation in the cost and benefit analysis in Section 4.0. Seven of these projects were identified in priority subwatersheds. Sedimentation and erosion were problems found at many reaches (Photos 4, 5, 6). In addition, reaches often had inadequate vegetative buffers (Photo 7). All of these problems decrease channel stability and available habitat to support robust aquatic communities. Recommendations for these projects are summarized in Table 4. Recommended project techniques are discussed in the following section. Project locations are shown in Figure 7.

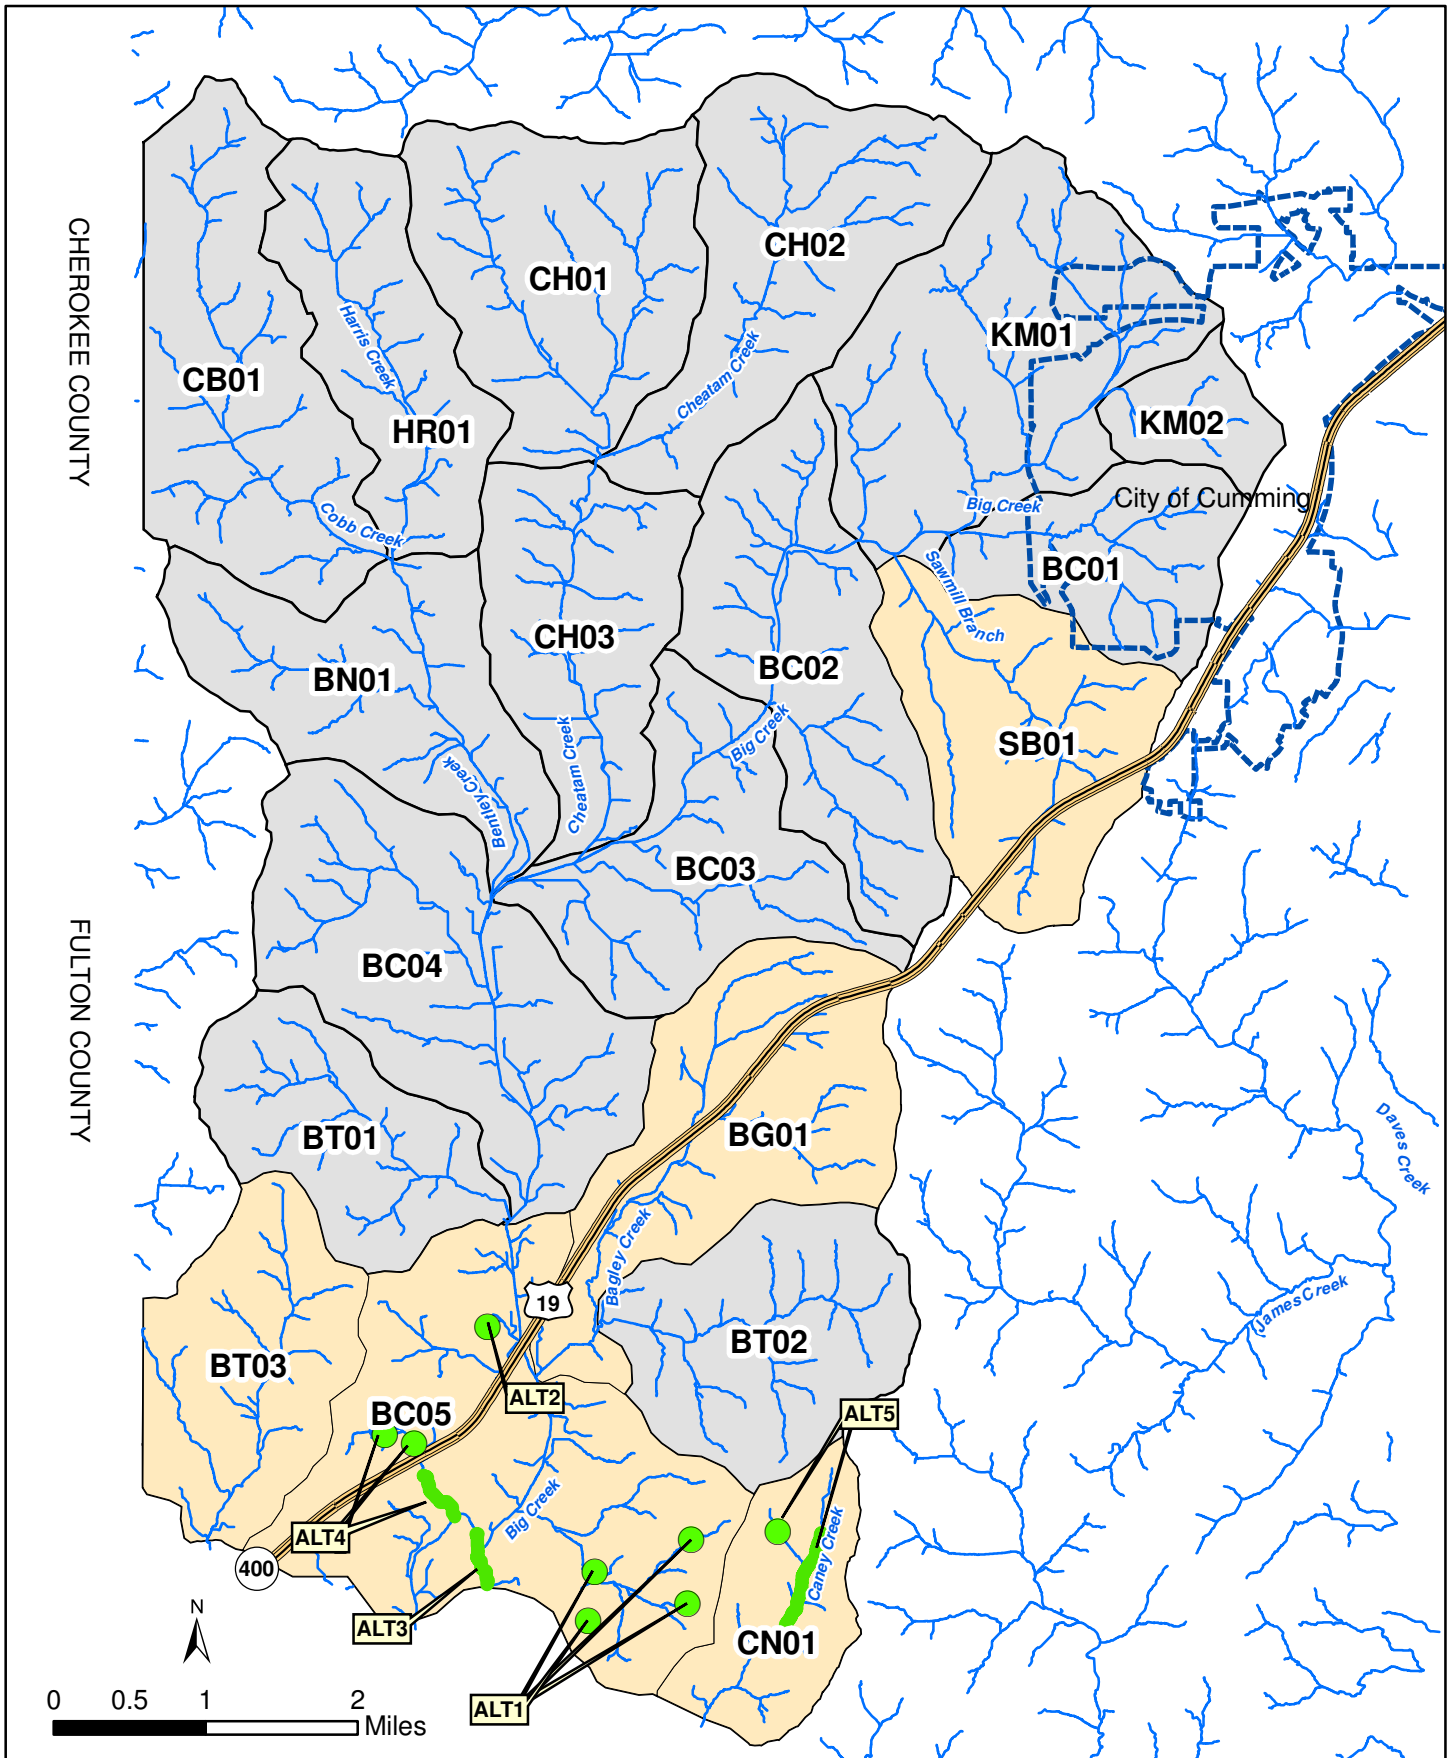
Figure 8
 Project Alternatives
 Big Creek Watershed Improvement Plan
 Forsyth County, GA

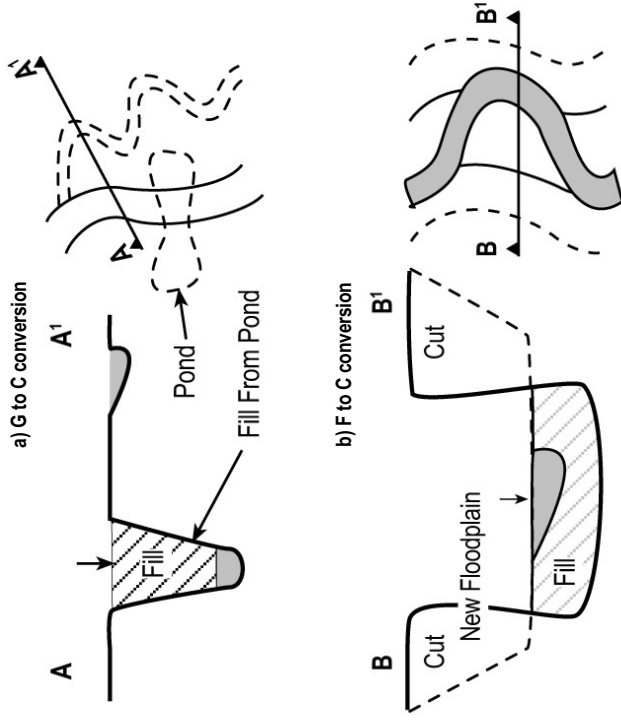
Level of Restoration 1 - Convert G and/or F stream types to C, B, or E at previous elevation with floodplain.

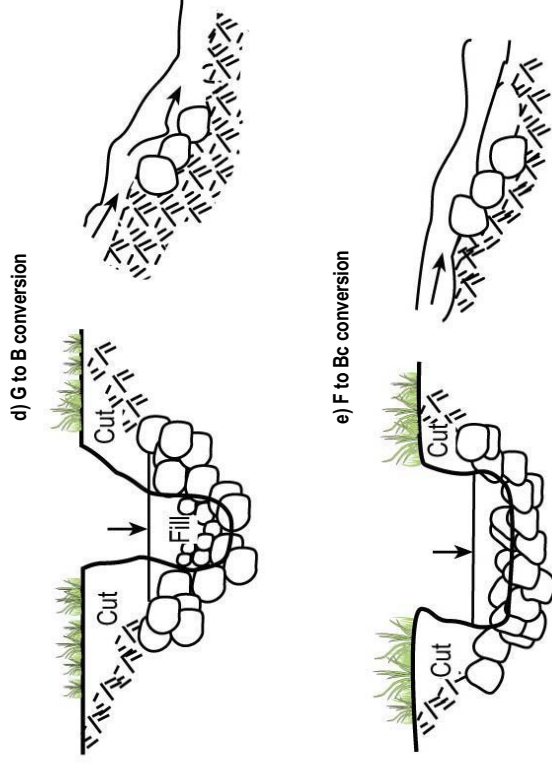
Level of Restoration 3 - Convert to a new stream type without an active floodplain, but containing a floodprone area. Convert G to B stream type, or F to Bc.

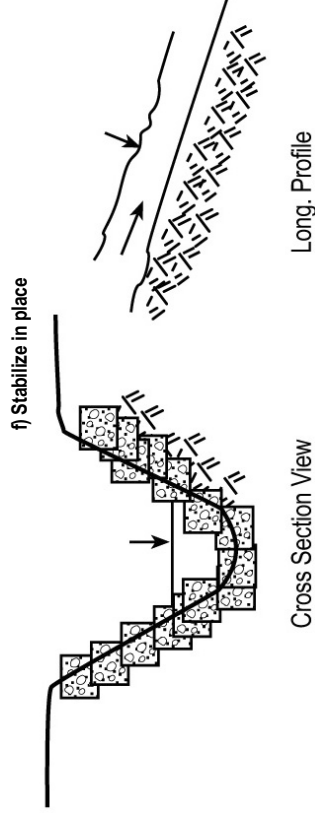
Level of Restoration 5 - Maintain existing channel shape. Stabilize eroded failing banks that pose threat to property/loss and/or feature erosion problem in otherwise relatively stable reach.

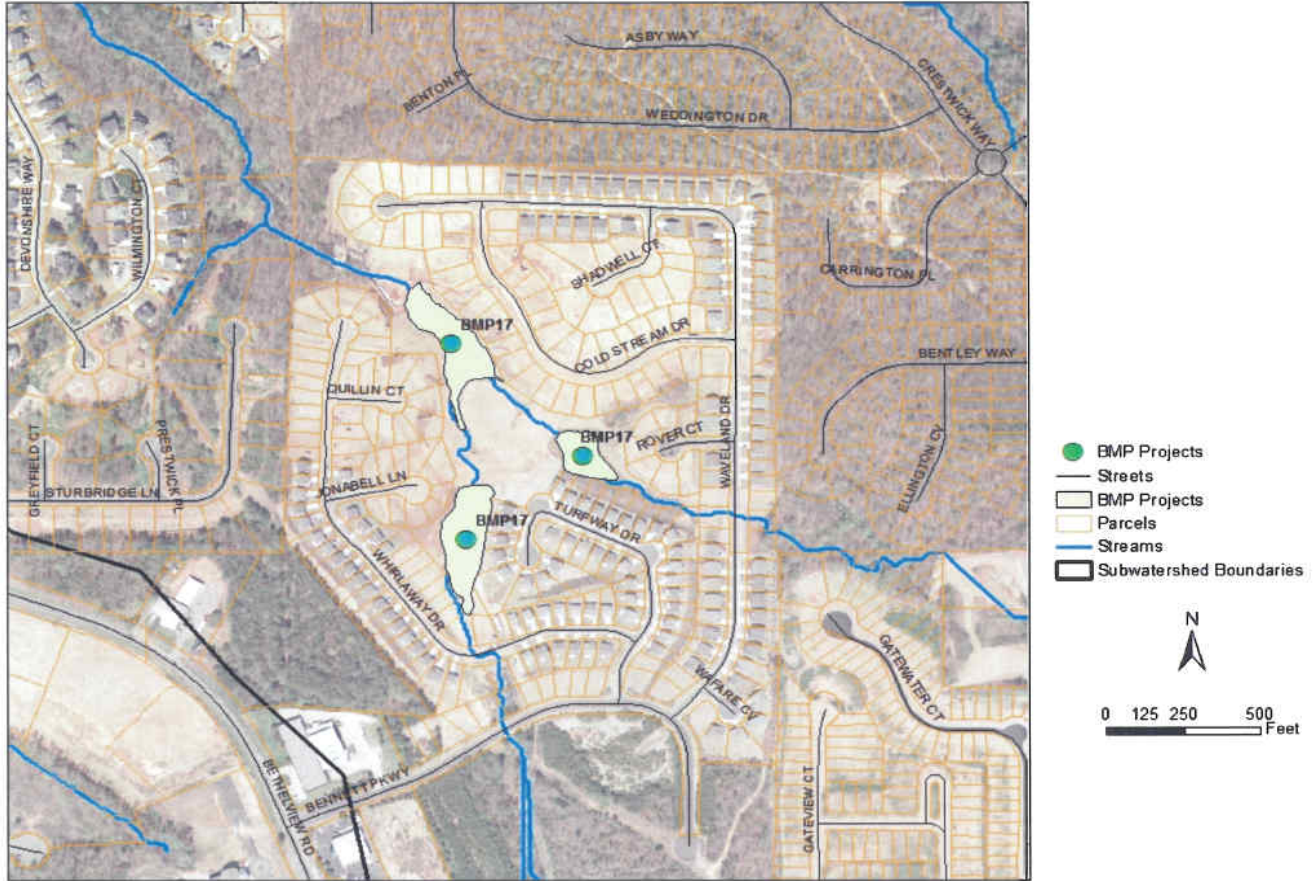
Figure 2: Plan View of BMP Retrofit Project with Aerial

Pond level at high water mark at time of observation. Sluice is damp, but barely flowing. Significant erosion downstream of sluice suggests high stormwater flows from storm drains into pond create high velocity flows out of pond.
